SCHEDULED INSPECTION

Site Power (CPP) for – RDS, LAWKA, GELEKI Oil Group Gathering Stations, Assam, India

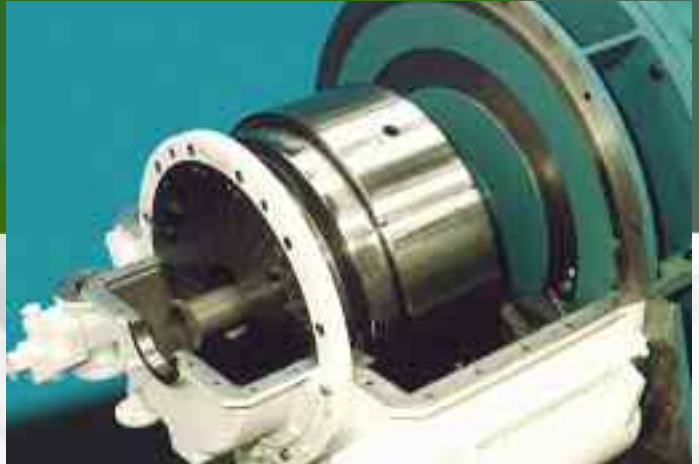
The 6 x Allison KB5 501 epicyclic gearboxes have been installed since 1987 and have received no maintenance other than basic visual inspections. The gearboxes have been in constant operation since installation and all have a working service life of 160,000 hours.

A full inspection was carried out as follows:

- Remove the Gear Internals from Gearcase.
- Remove Spindle End Covers and inspect Spindle bores for rust, dirt, and sludge. Remove deposits and clean thoroughly.

- Dismantle Gear completely and inspect all components in detail, paying particular attention to all running teeth, coupling teeth, and all whitmetal Bearing surfaces.

- Remove and dismantle the Oil Pump. Visually check for wear and deterioration of Pump Rotors, Body and Mechanical Seal.
- Remove and dismantle the Oil Pump Drive and Idler and the Starter Drive Assembly and Idler to check condition of the Rolling Element Bearings and the Spragg Clutch.

- Check that all oil holes and oil ways are clear. Remove any sludge centrifuged out in the bores of the Inner and Outer Annulus Coupling Rings and the High Speed Coupling Sleeve between the Sunwheel and Sunwheel Coupling Flange.

- Partially re-assemble the Gear in order to check alignment.
- Re-assemble the Gear using new Locking Plates and Tab Washers, and ensure that all Helicoil Inserts are in good condition.
